Slum Factsheet **Ambika Nagar**

Name of Slum: Ambika Nagar

Slum Address: Ambika Nagar, Peth Road, Opp. Engineer's Workshop, near canal, Nashik.
(Inc. Landmark)

Date of Survey: 20.05.10

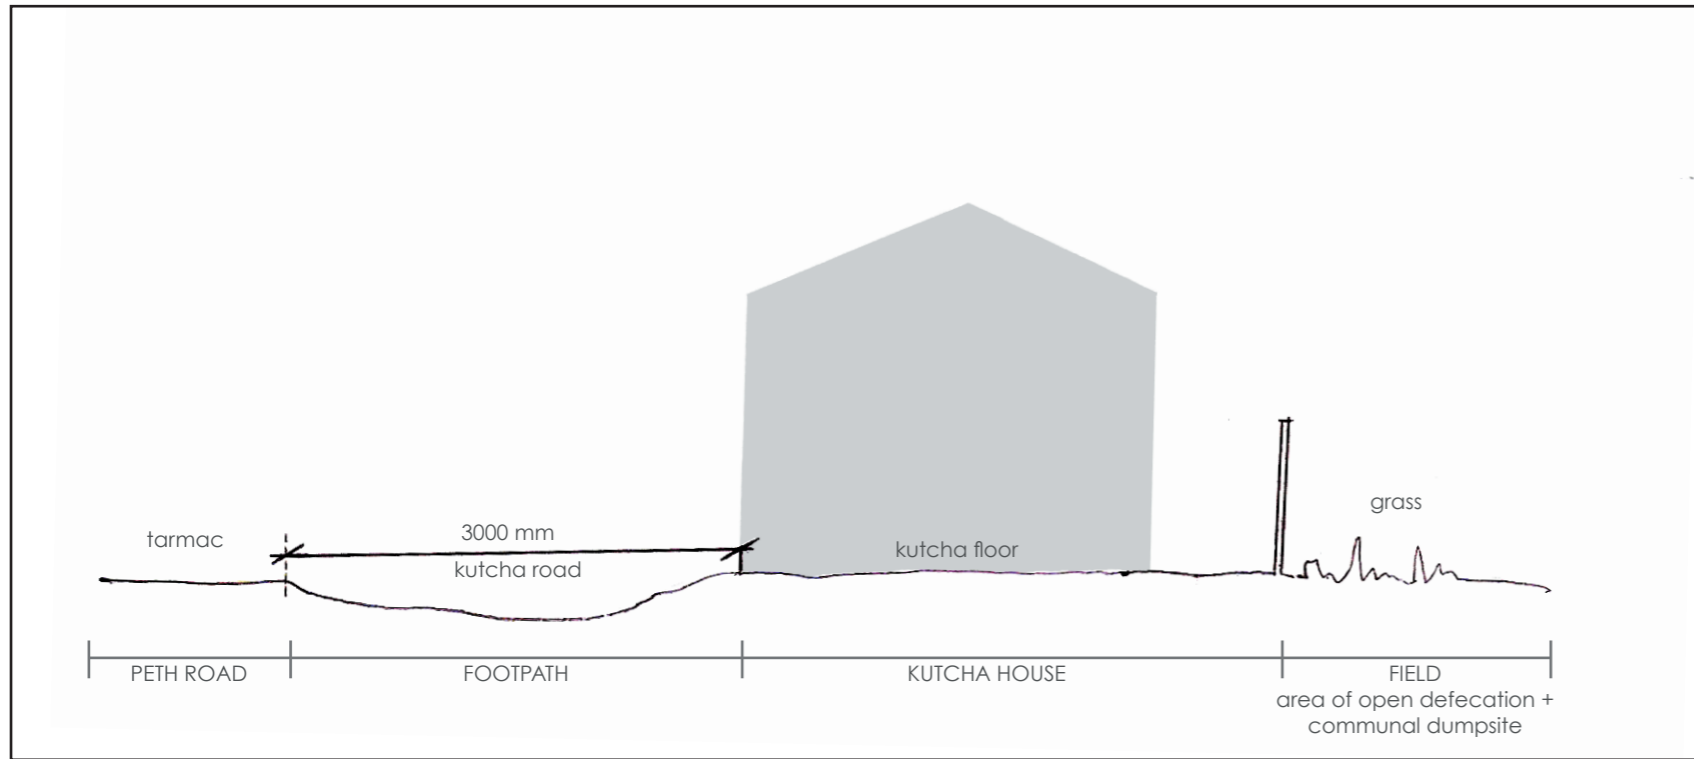
Section A: Some houses are built directly off the kutcha floor finish, building directly on top of compacted gravel. In these cases the internal floor level is that of the external level with no buffer or water protection.

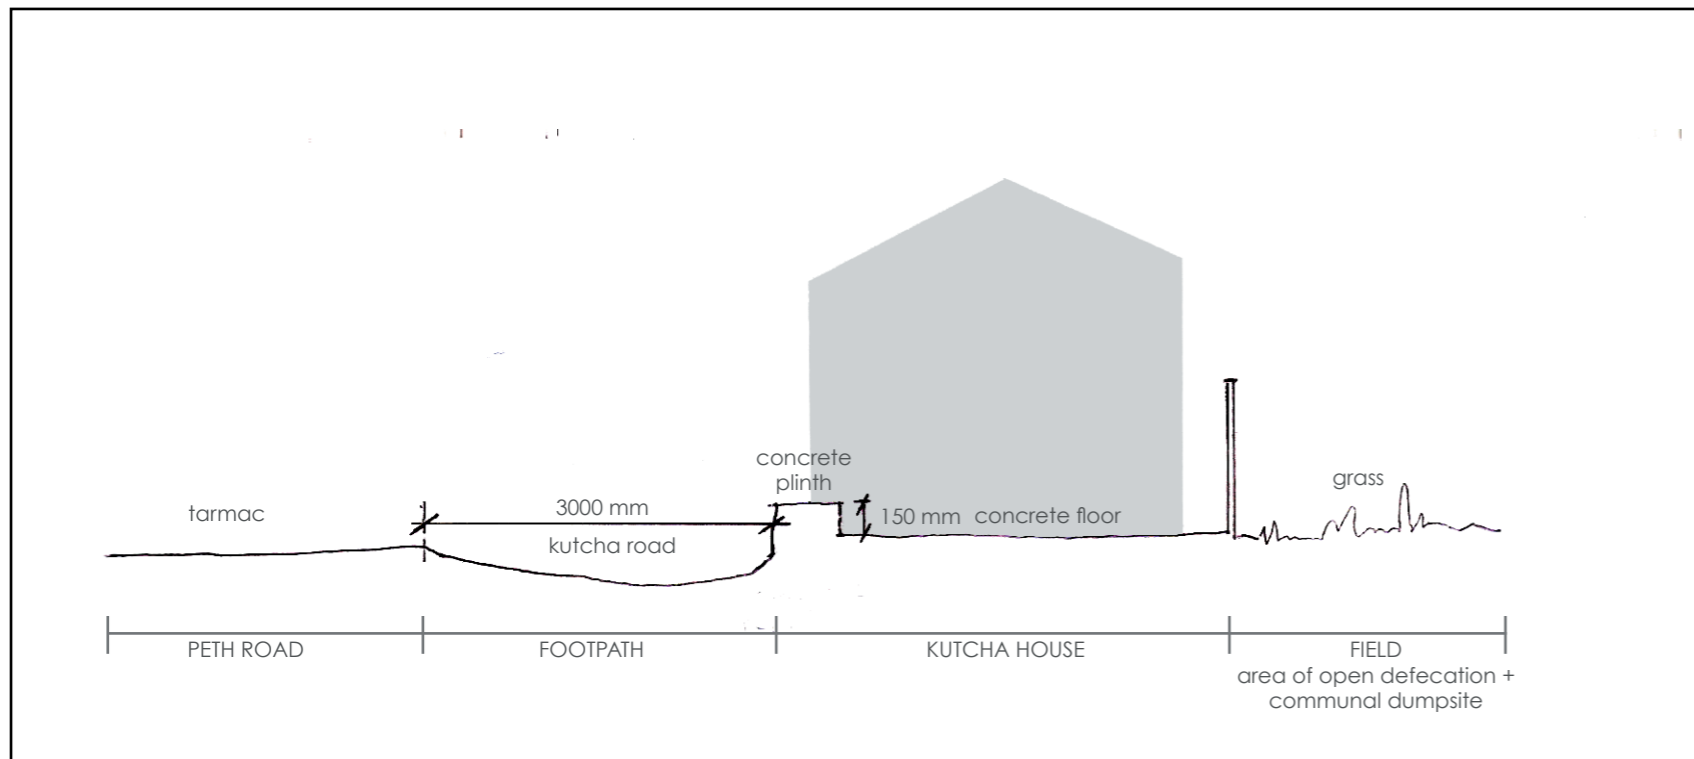
Section B: In other cases, some dwellings have a concrete or stone plinth that acts as a buffer between inside and out, providing stability to the structure giving protection against possible flooding.

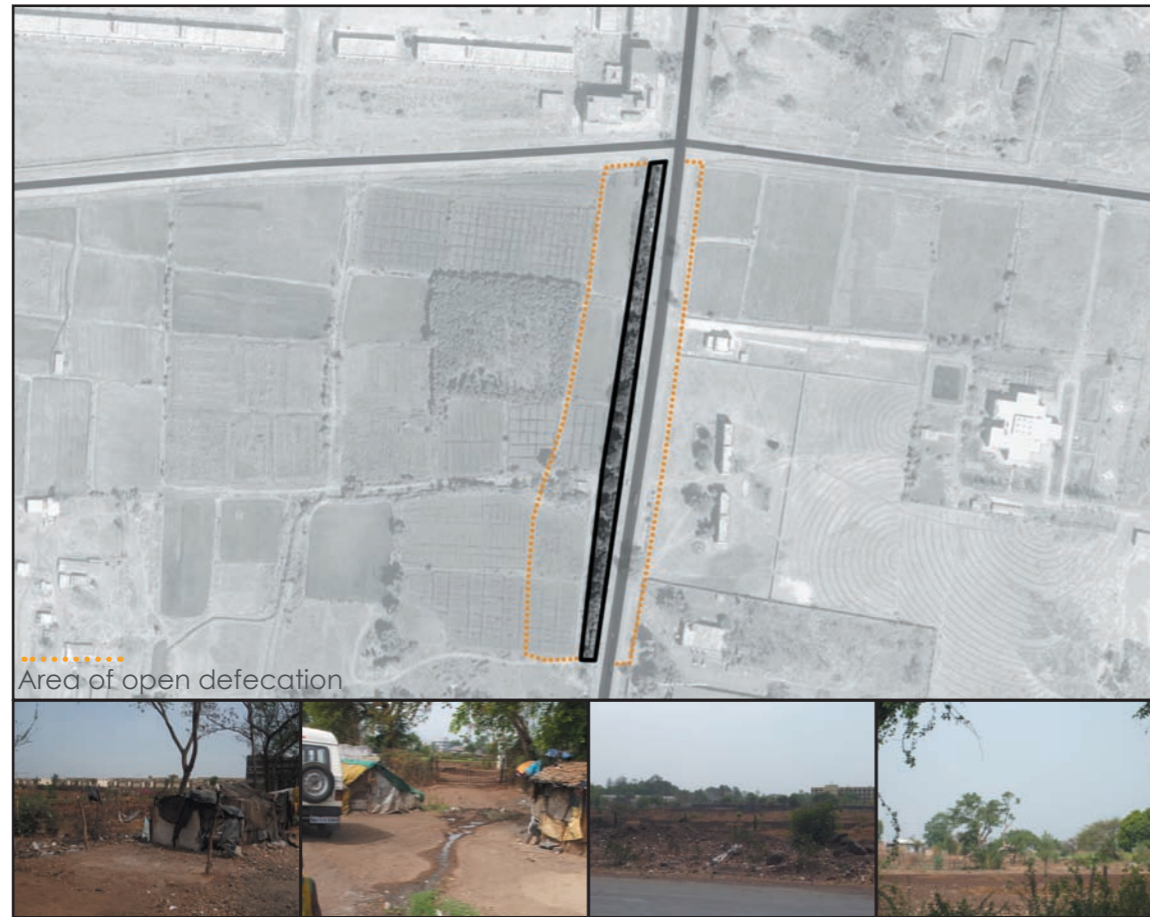
Sanitary Map and Key Photographs:

Total block no. (m / f / mixed)	- 0	Maintained by	- NA
Sewage disposal system	- NA	Water source	- NA
Electrical provision (for pumps and lighting)	- NA		
Total male seats	- 0	Children's facility	- 0
Total female seats	- 0		
General usage of male and female toilets	- NA		
General condition and cleanliness of stalls	- NA		
Description of payment (month / single use)	- NA		
In the case of no or inadequate provision	- Open defecation - dwellers defecate in the open field behind the slum as well as in open space across the road.

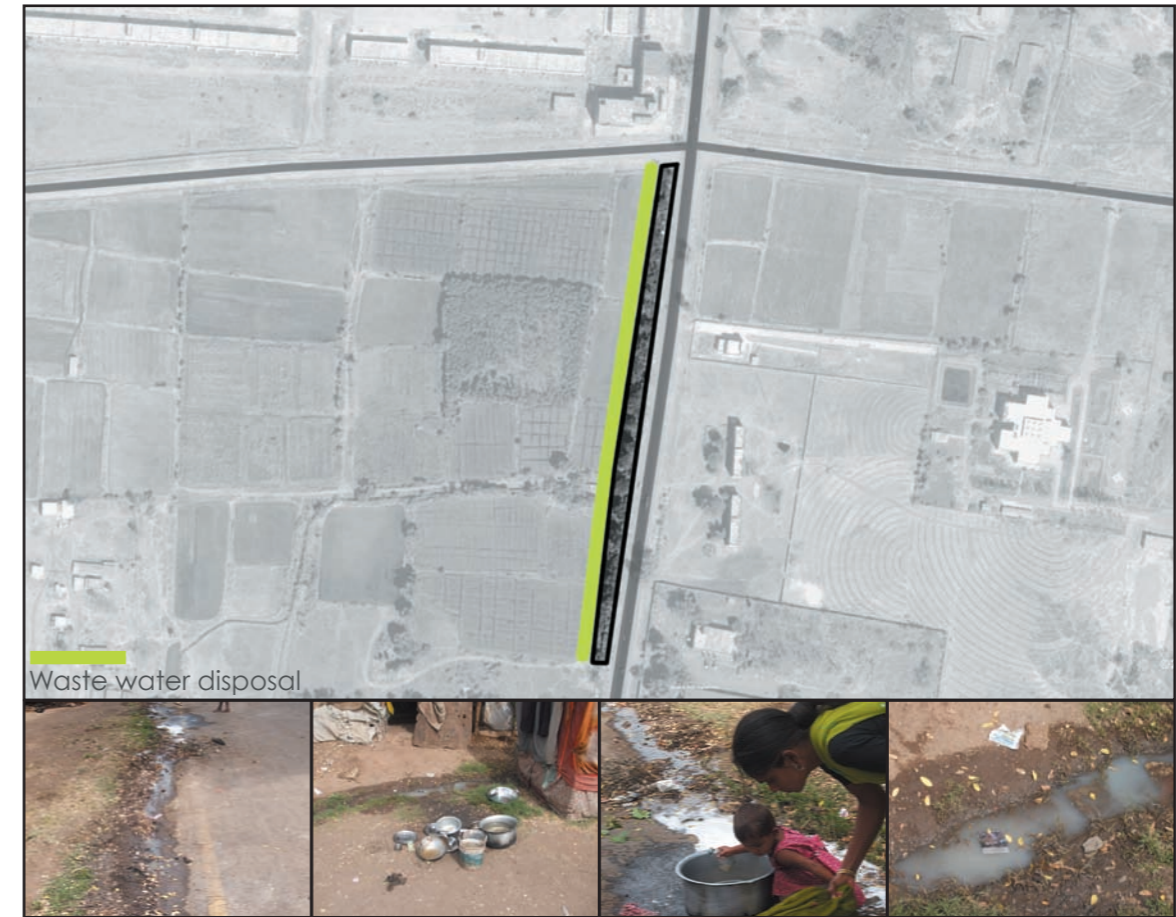
Drain Location Map and Key Photographs:

Type of drains (Underground / Open)	- None - Water is expelled directly onto the ground as well as in the field behind the slum.
Connection to City sewer line	- NR
Quality of gutters and overflow risk	- Greywater and household waste water gathers in areas of depression and along the main road.
Effectiveness of gutter gradient	- Water does not run into a gradient, instead water pools and collects in areas of slight depression.

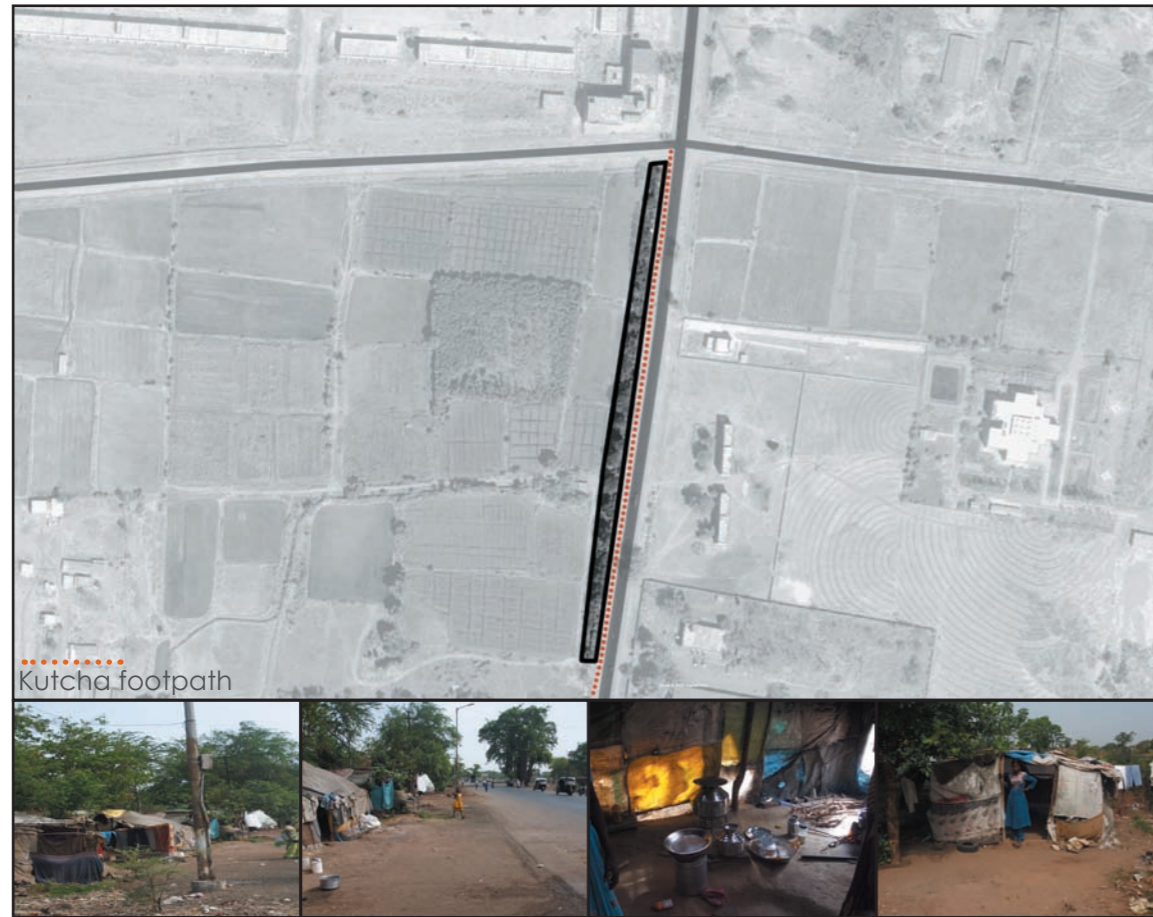
Road Condition Map and Key Photographs:

- Type and quality of road finishes** - The slum is built upon compacted dirt and gravel footpath. When dry the path is easily accessible, however it will absorb rainwater as well as surface run off water from the tarmac road adjacent.

- Level variation between slum and main road level** - The main road sits slightly higher than the gravel path. (see sections.) This means that water will collect in areas of depression and due to the lack of adequate drainage the water has nowhere to flow causing a possible risk of flooding.

- Level variation between individual houses and internal road levels** - The internal floor level of houses vary from being level with the external ground, or higher, sitting either directly on top of the ground or on a concrete plinth (see sections.) There are no circumstances where the internal level is below that of the external.

- General observations** - The slum road condition becomes significantly worse when wet as water collects and the gravel becomes very hazardous to walk on.

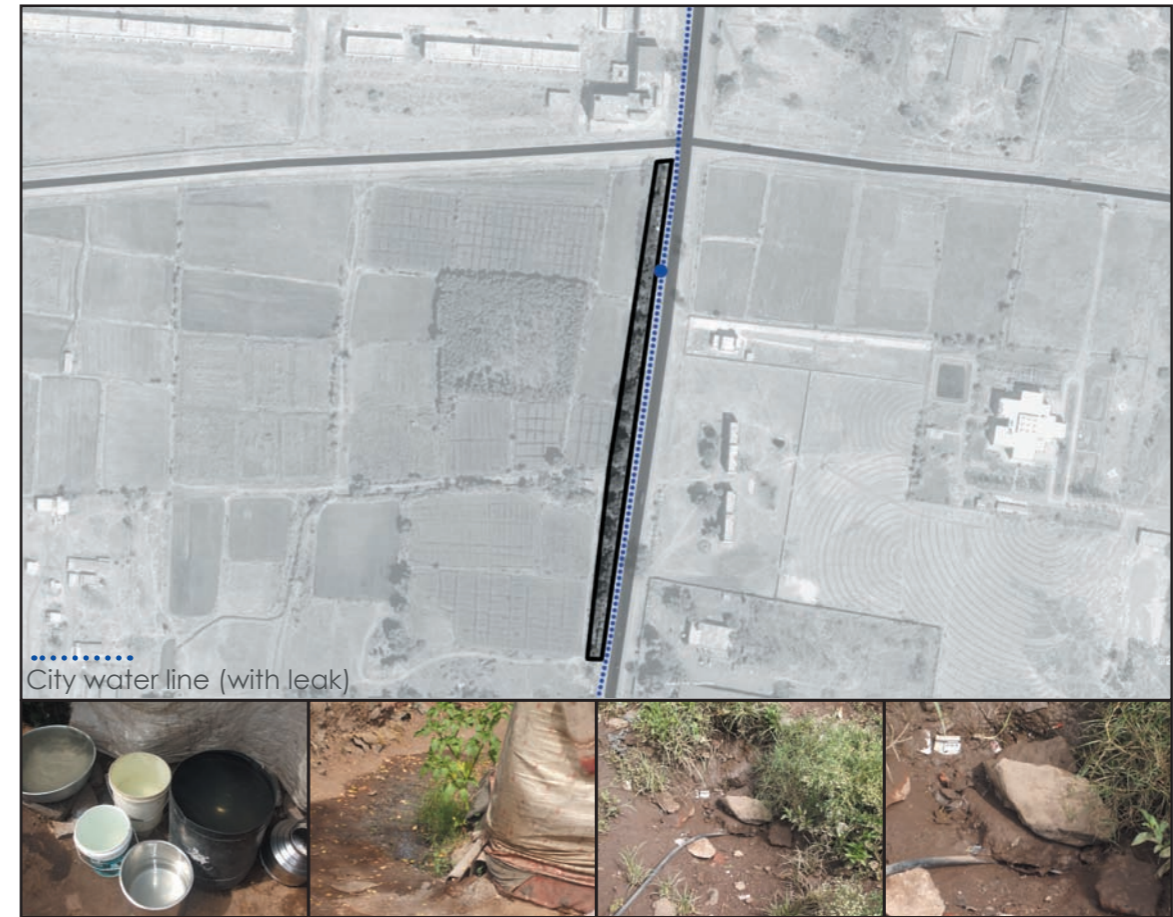
Water Supply Map and Key Photographs:

- Total number of hand pump** (In-use / Unused) - 0
- Total number of stand posts** (In-use / Unused) - 0
- Total number of taps** (In-use / Unused) - 0
- Quality of water** - NA **Water pressure** - NA
- Water availability timings** - NA
- Alternative sources of water** - The community sources water from a leak in a city water line that runs directly under the site.
- Payment for individual water connections** - NA

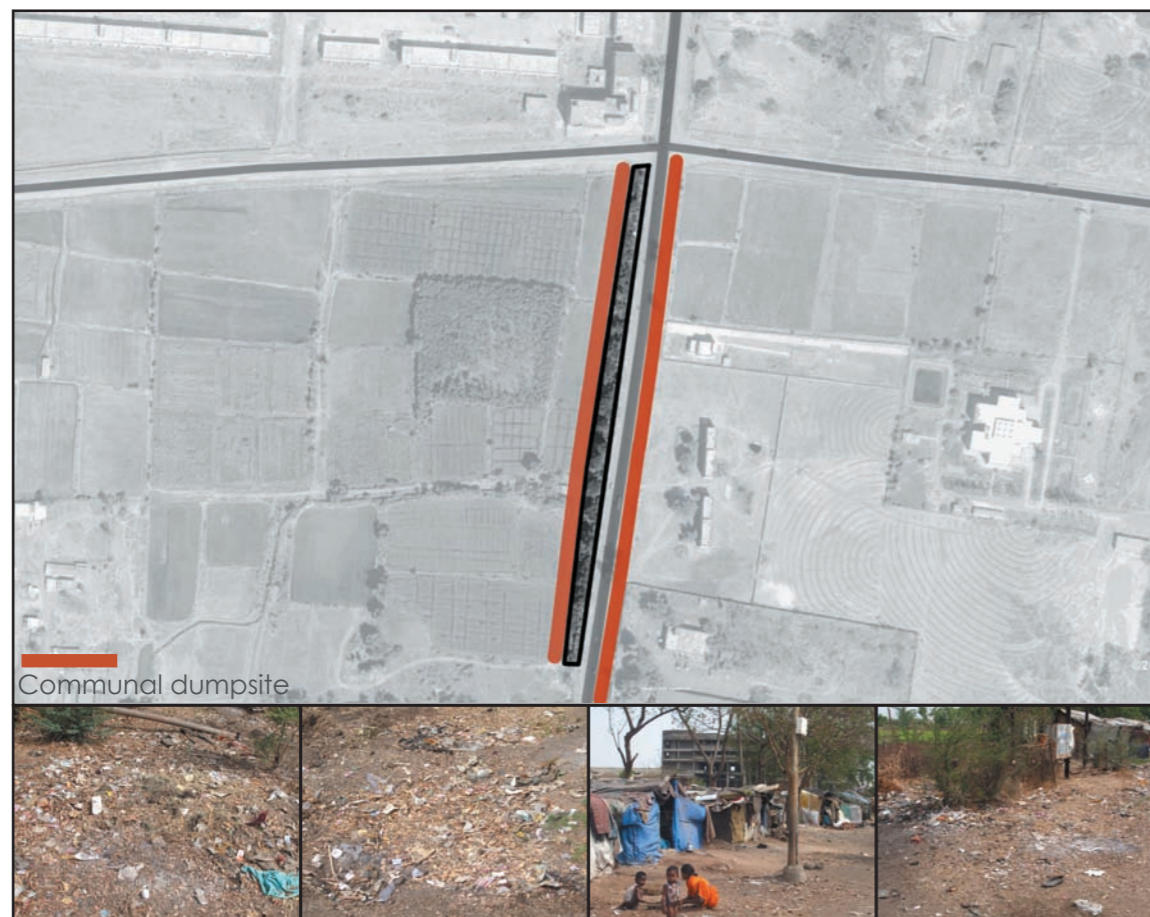
Waste Map and Key Photographs:

- Presence of community dump sites** - Garbage is disposed of in field directly behind the slum, and in an open space opposite the slum across the main road.

- General observations** - No provision for waste disposal within the slum means that the condition and quality of the surrounding areas of open land used for communal dump sites are becoming severely affected. This is detrimental to the agricultural land.

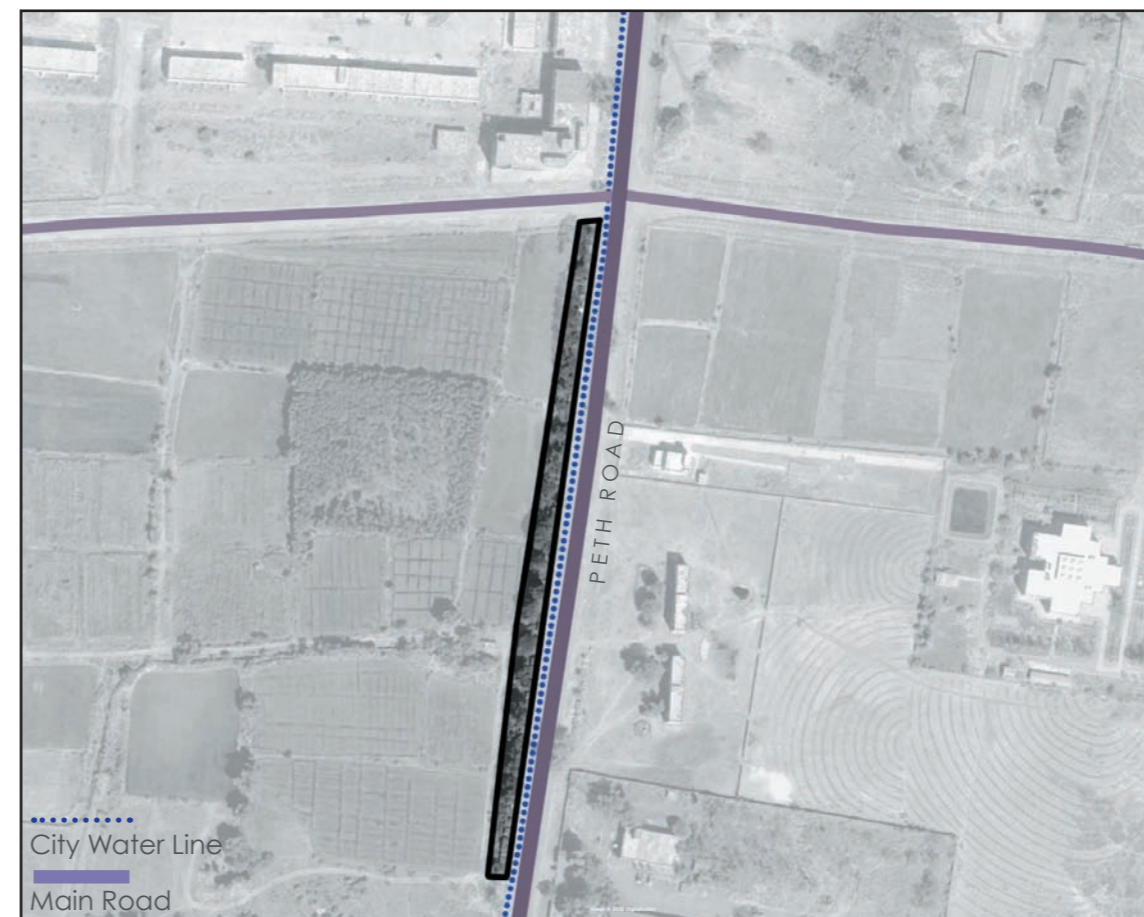
Resource / Hazard Location Map:

- Nearest city water line** - A city water line runs directly underneath the slum, running north / south adjacent to Peth road. The residents are not directly connected to this water line, however do gain access to water from it through a leak in the pipe.

- Nearest main road** - Peth Road is a very busy road with at least two lanes of traffic in each direction. It runs north / south adjacent to the eastern boundary.

- General observations** - The site is located in an area of land, with agricultural land abutting the slum on all sides. The close proximity of the road to the dwellings could be potentially very hazardous if children are wanting to play near their homes.
