Slum Factsheet **Ambika Nagar**

Name of Slum: Ambika Nagar

Slum Address: Ambika Nagar, Peth Road, Opp. Engineer's Workshop, near canal, Nashik.
(Inc. Landmark)

Date of Survey: 20.05.10

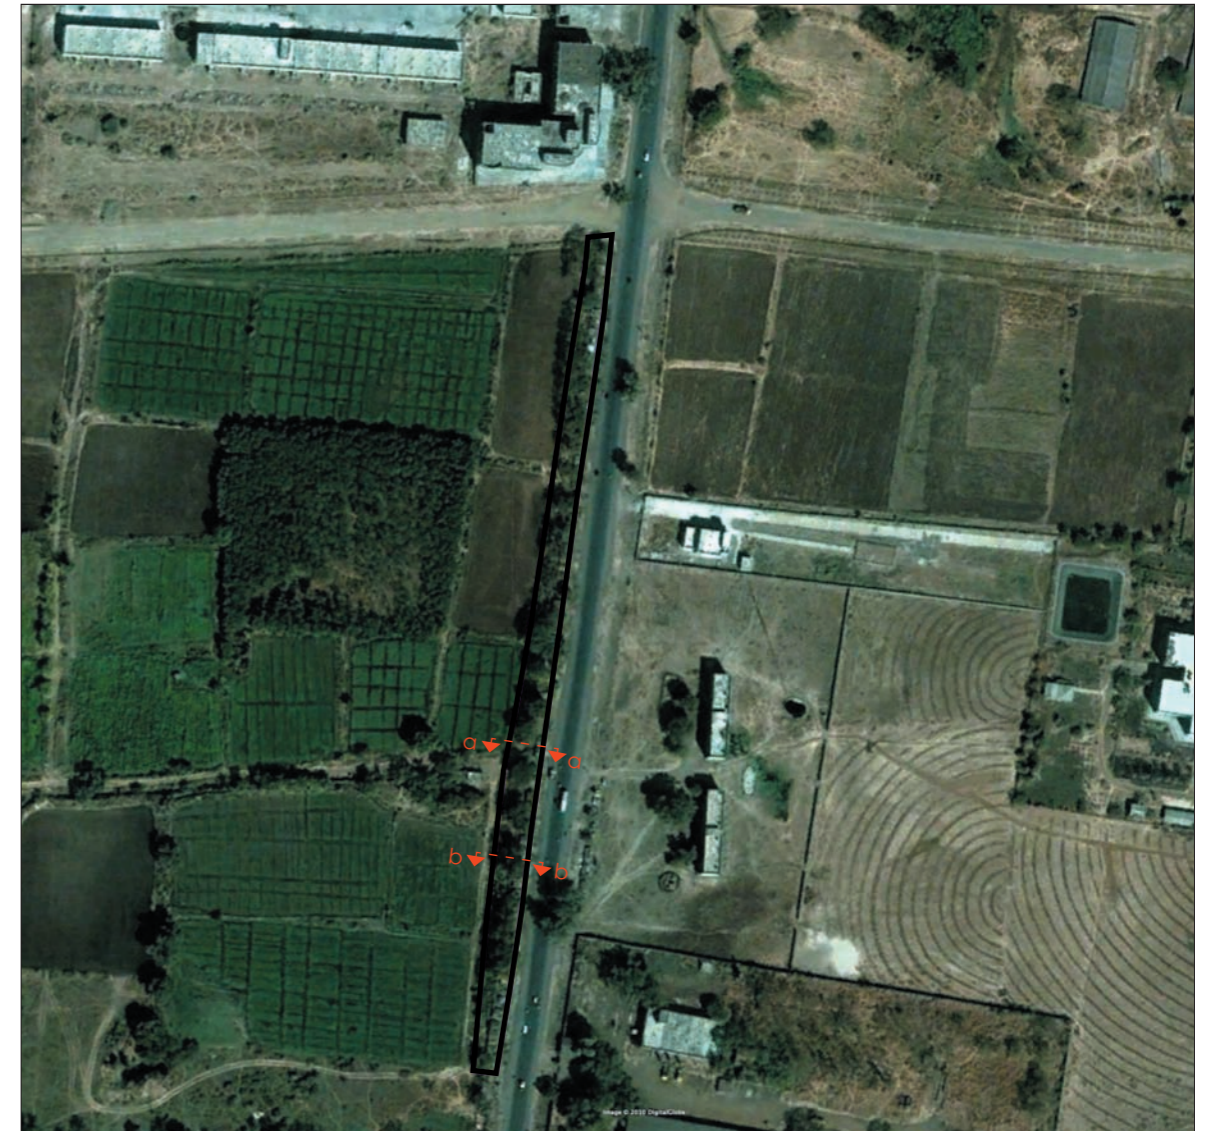
Section Locations:

Overall the slum is located on a flat stretch of land adjacent to a main road. There is however a slight change in level where the slum meets the main road as the surface finish changes from gravel to tarmac. Here is the only concern for possible flooding as ponding will occur.

Section A: Some houses are built directly off the kutcha floor finish, building directly on top of compacted gravel. In these cases the internal floor level is that of the external level with no buffer or water protection.

Section B: In other cases, some dwellings have a concrete or stone plinth that acts as a buffer between inside and out, providing stability to the structure giving protection against possible flooding.
